Oncore Healthy Homes Assessment

3 Dec 2021 / Oaks Property Management

Property Address	39 Fairlight Place, Manurewa, Auckland 2102, New Zealand (-37.0244415, 174.87927820000002)
Customer's Name	Oaks Property Management
Assessment Date & Time	3 Dec 2021 08:55 NZDT
Oncore Franchise	Jeremy Lowe
Assessor's Name	Jeremy Lowe

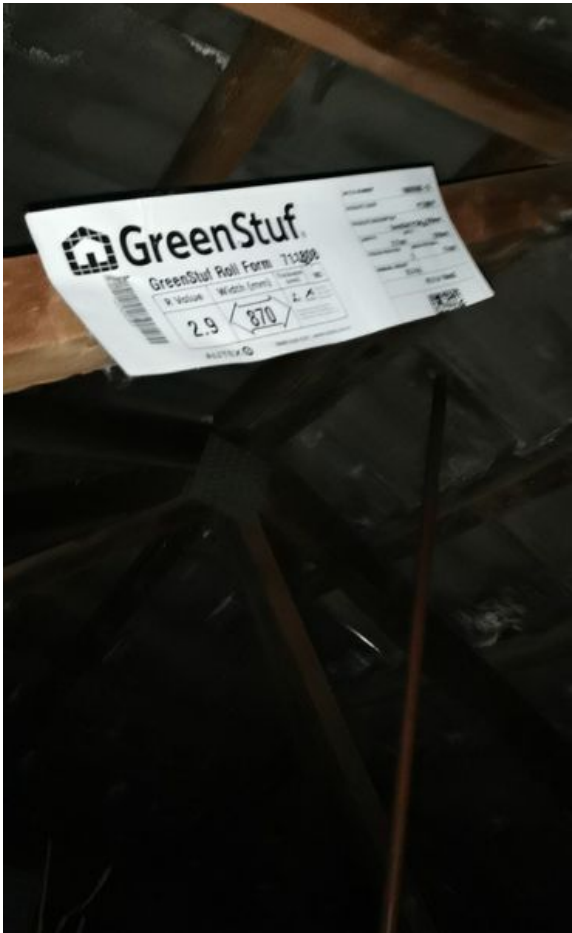
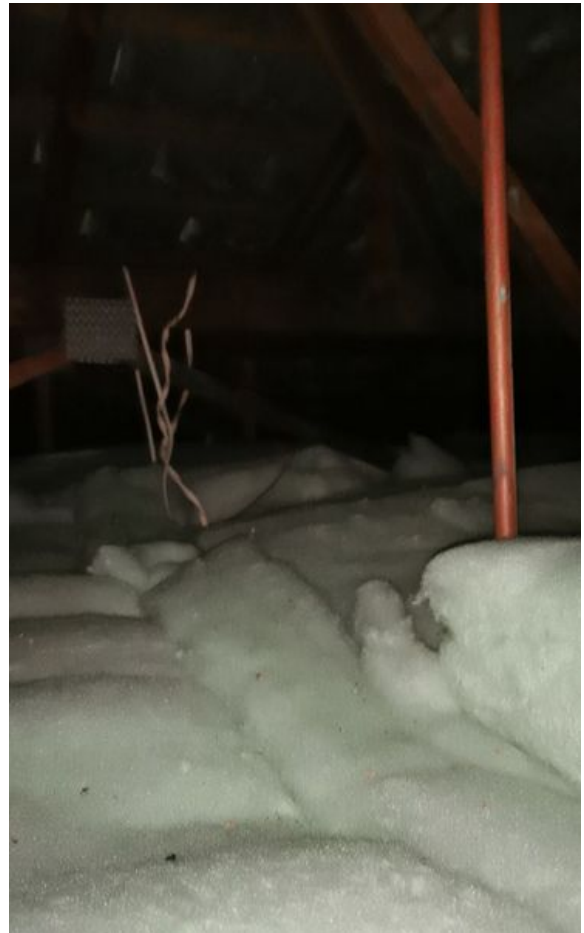
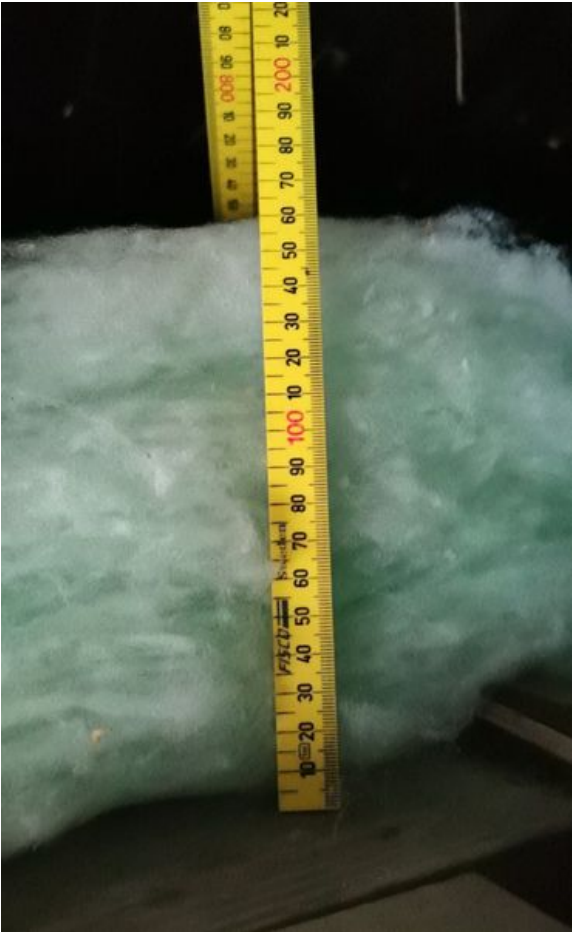
R-value/Thickness in mm: R2.9 / 160mm

Type of insulation: Polyester

Is the insulation in reasonable condition? Yes

Note: The ceiling insulation is at least 120mm thick and/or does have an R-value of at least 2.9 (climate zone 1&2) or 3.3 (climate zone 3) and it is also in reasonable condition. See attached photo(s).

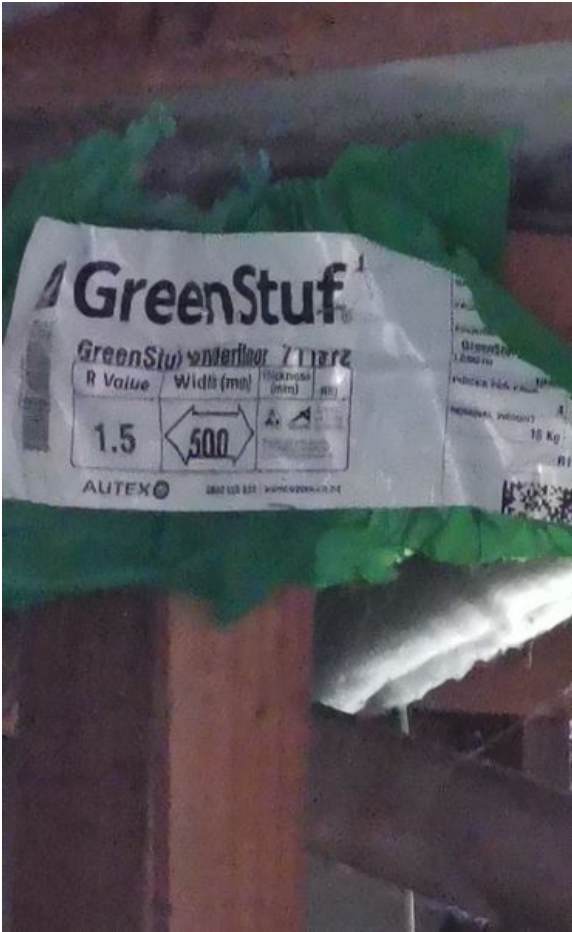
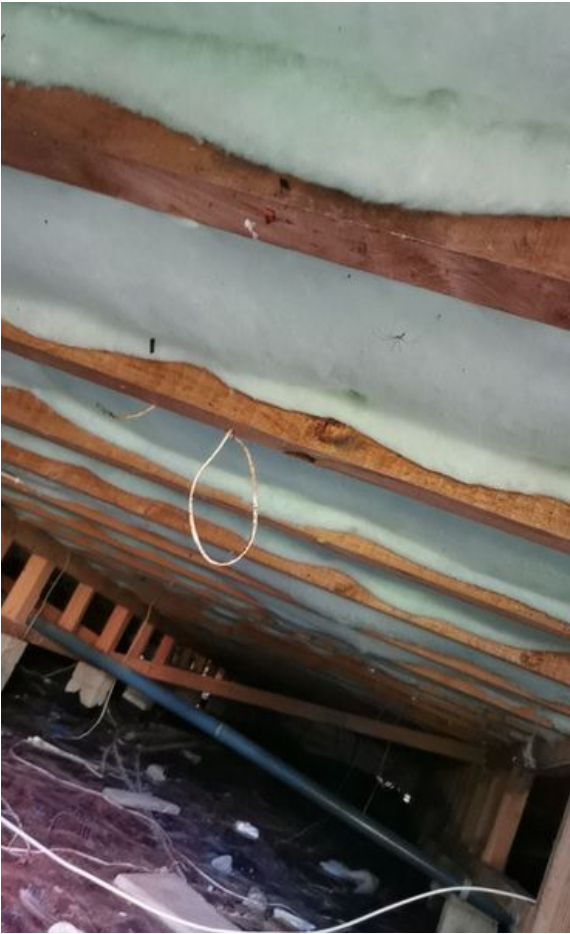
R-value/Thickness in mm: R1.5

Type of insulation: Polyester

Is the insulation in reasonable condition? Yes

Note: The underfloor insulation has an R-Value of 1.3 or more and is in reasonable condition. See attached photo(s).

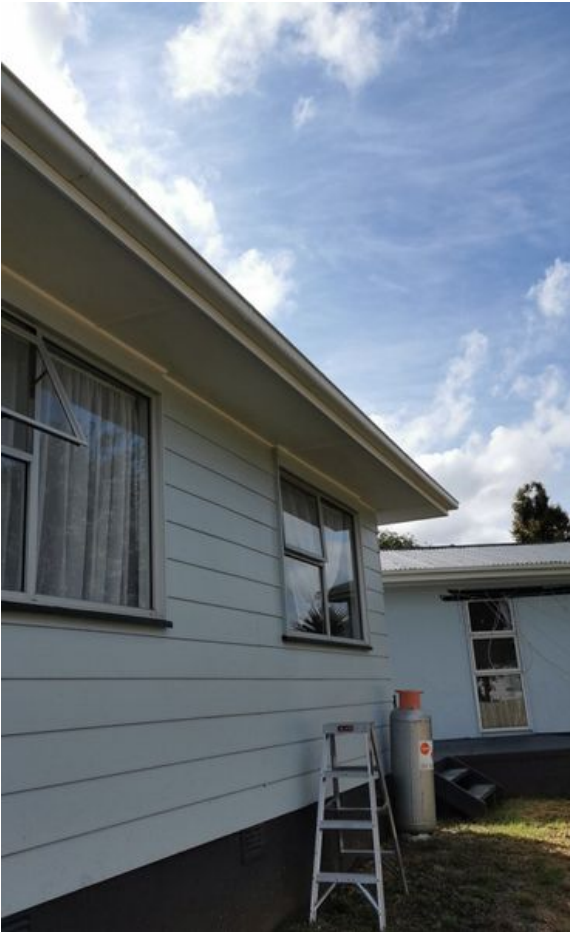
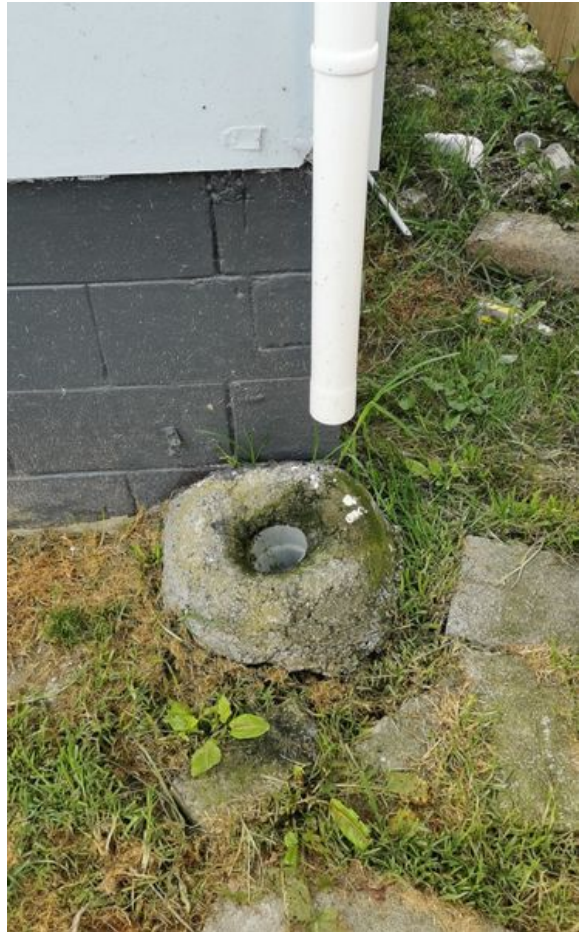
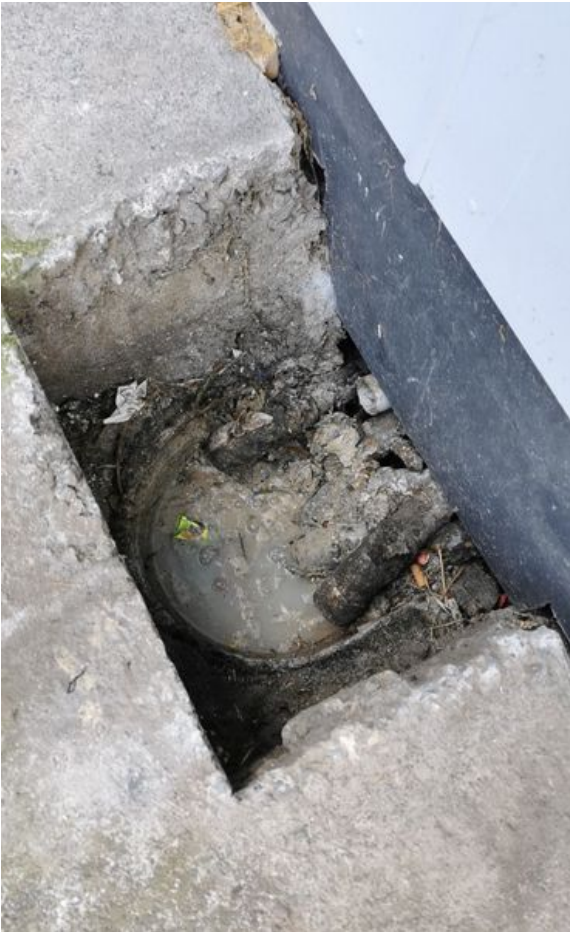
Not Compliant (work needed)

The gully trap is blocked and needs to be cleared.

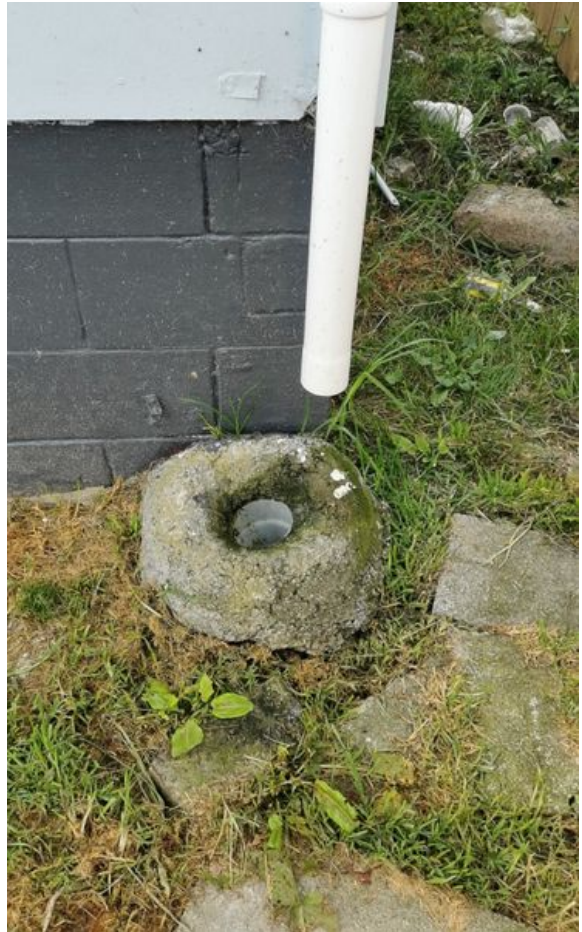
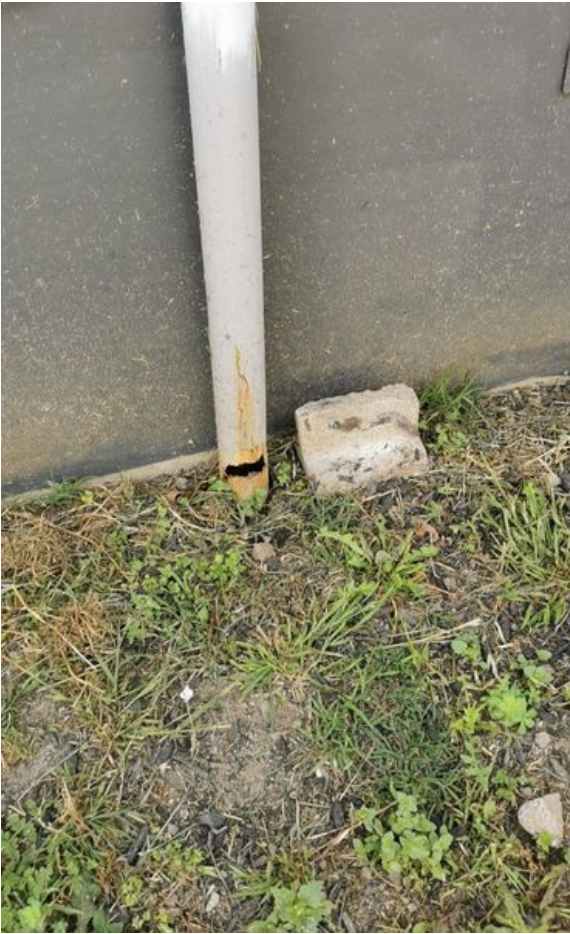
Are all gutters connected to a downpipe (directly or via another connected gutter)?

No

The downpipe for the sleep out needs to be connected correctly to the stormwater. The other downpipe needs to be repaired.

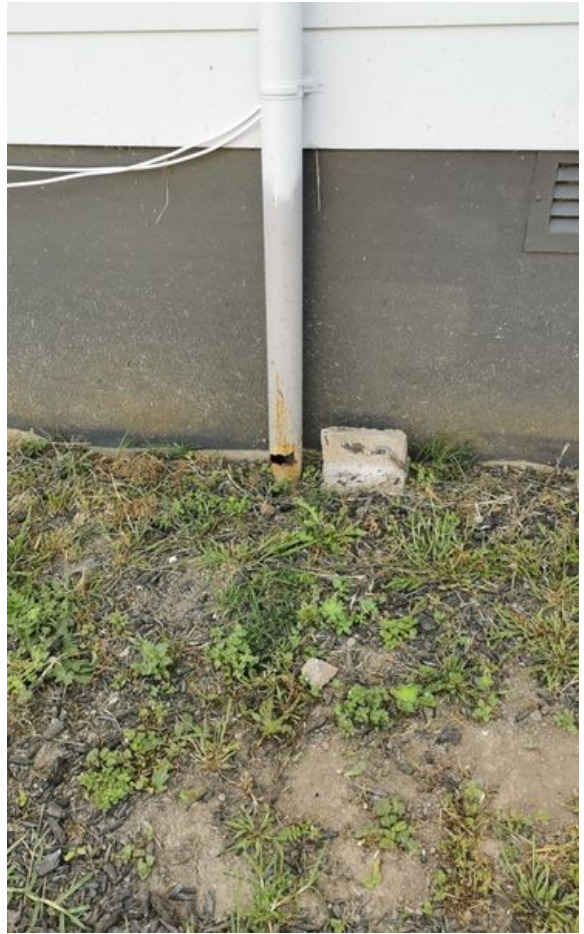
Photo 12

Are all gutters and downpipes intact (not broken, corroded or with pieces missing) and fixed well to the home (not loose)?

No

Gutters, down pipes and drains are insufficient for the removal of all storm, surface and ground water. There are some issues preventing them from being in good working order. See attached photo(s).

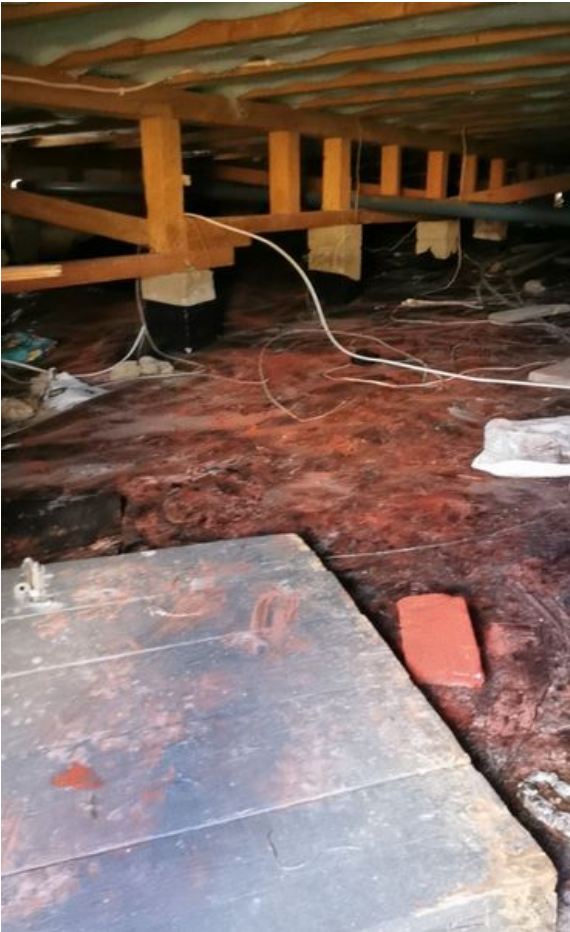
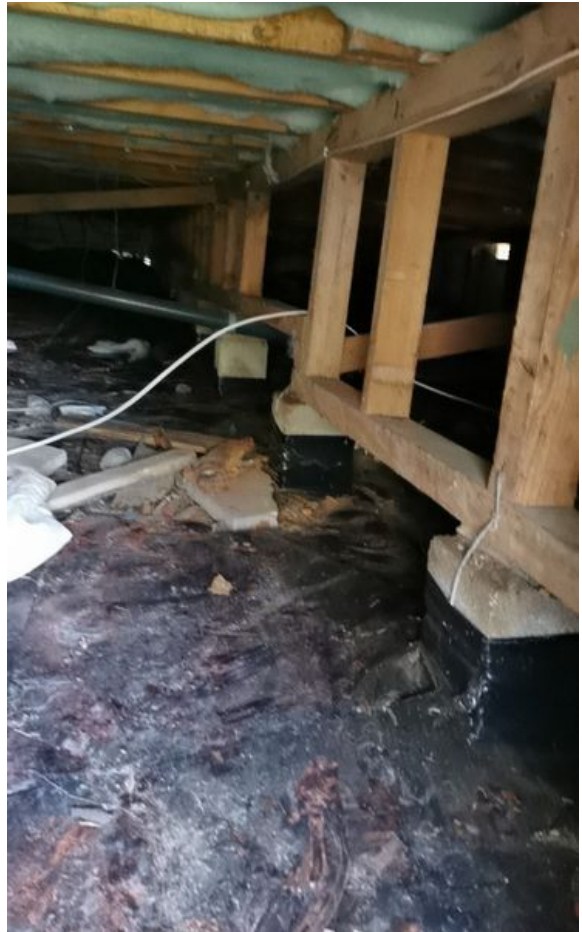
Does the property have a subfloor space that is at least 50% enclosed?

Yes

There is an existing ground moisture barrier that is free from significant damage (rips/holes/tears). See attached photo(s).

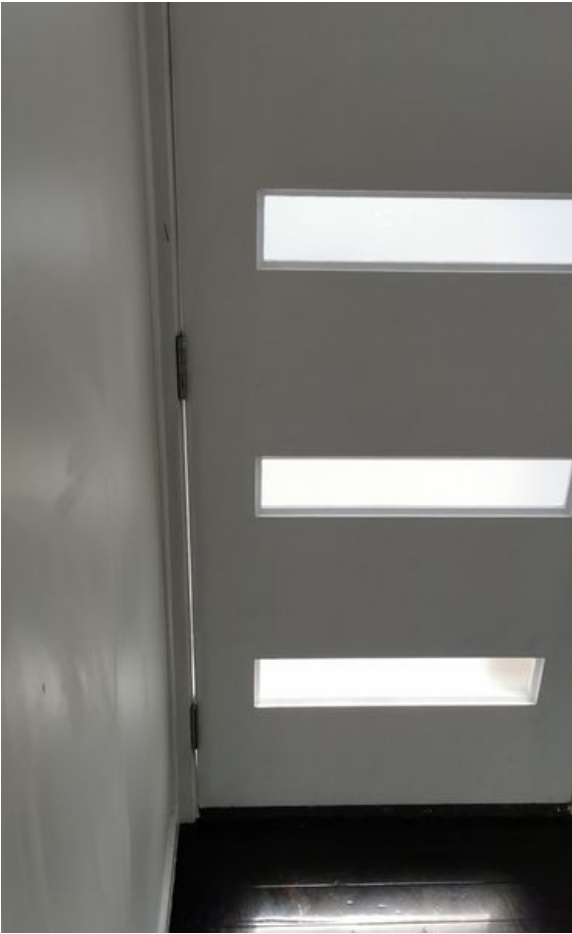
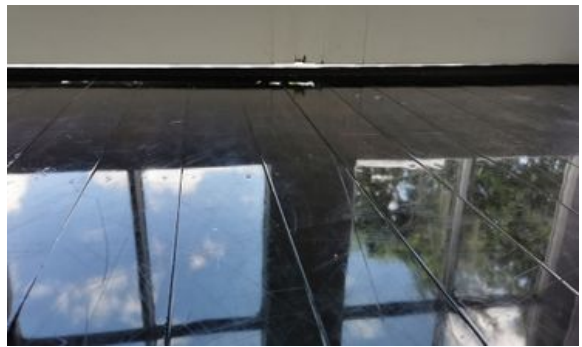
Not Compliant (work needed)

The gaps around the front door and under the French doors need to be sealed.

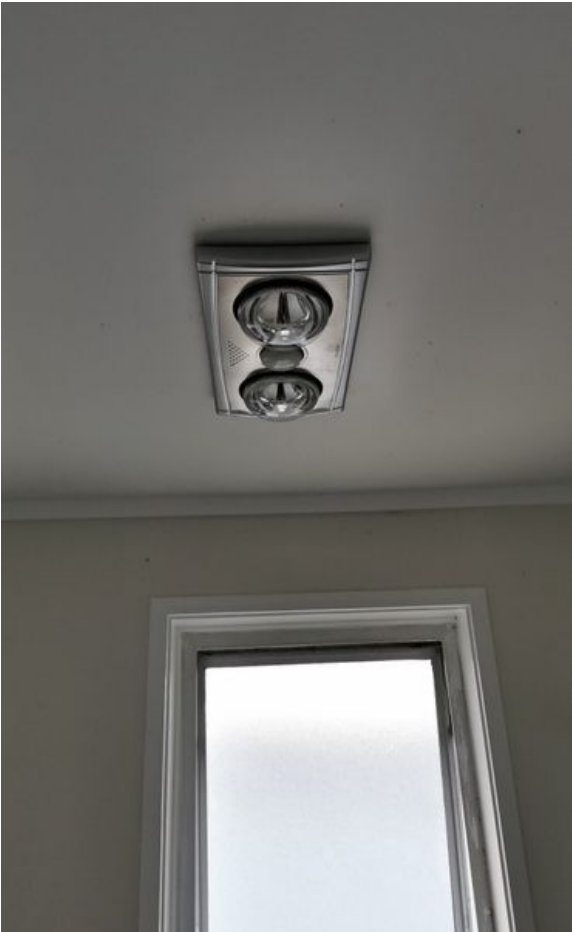
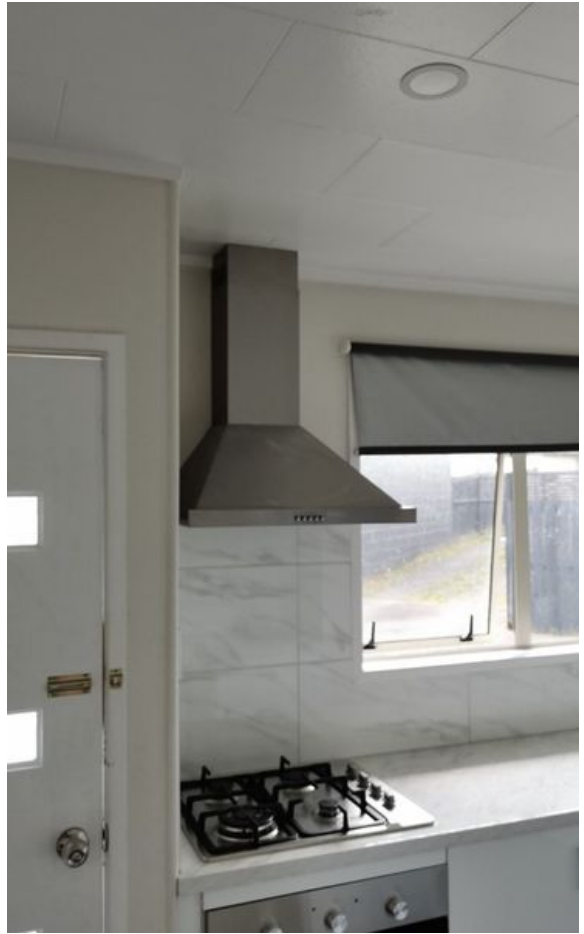
Fully Compliant

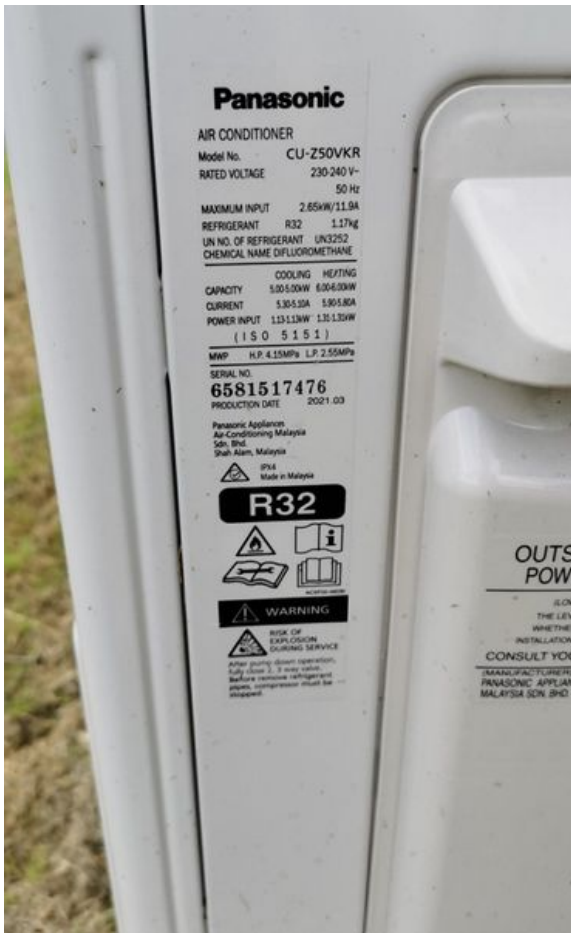
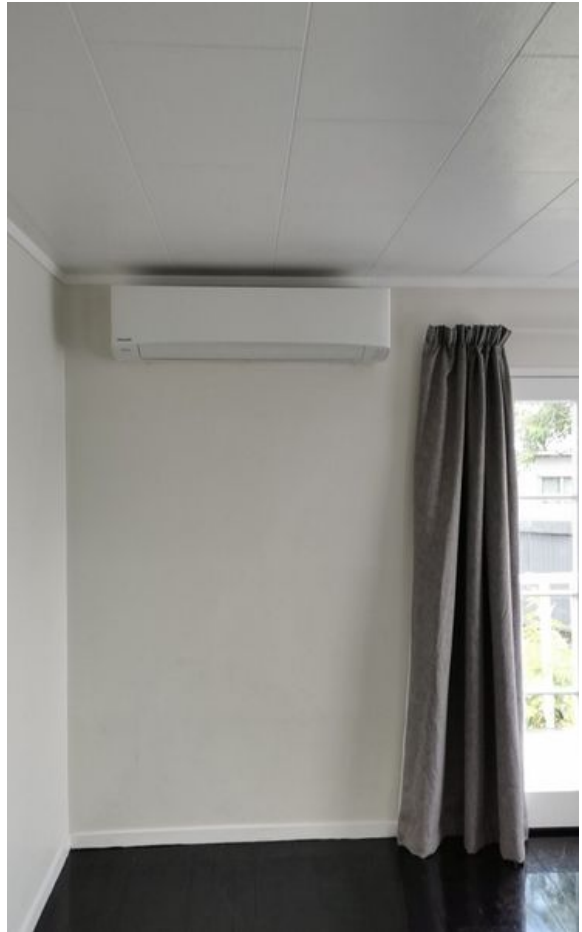
5.8kW

The main living area requires an approved fixed heating device with heating capacity of 5.8kw. The existing heat pump provides 6kW

The main living room has an approved heating device with the required kW heating rating. See attached photo(s).

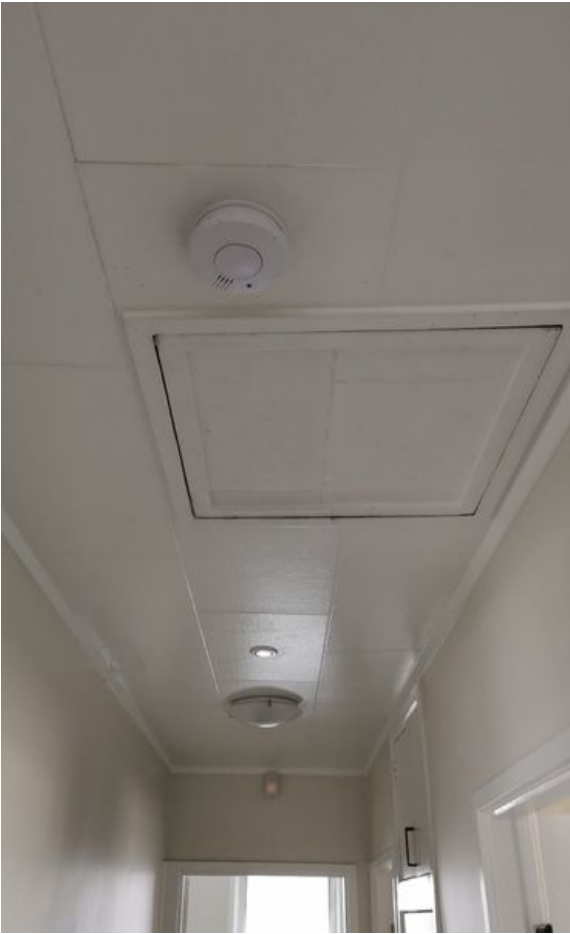
Photo 21

Is there a working smoke alarm installed in every bedroom or within 3 meters of every bedroom?

Yes
